# Engineering Issues in Barrowford Park

Scott Whalley  
Engineering Manager  
Pendle Borough Council  
September 2019

## Executive Summary

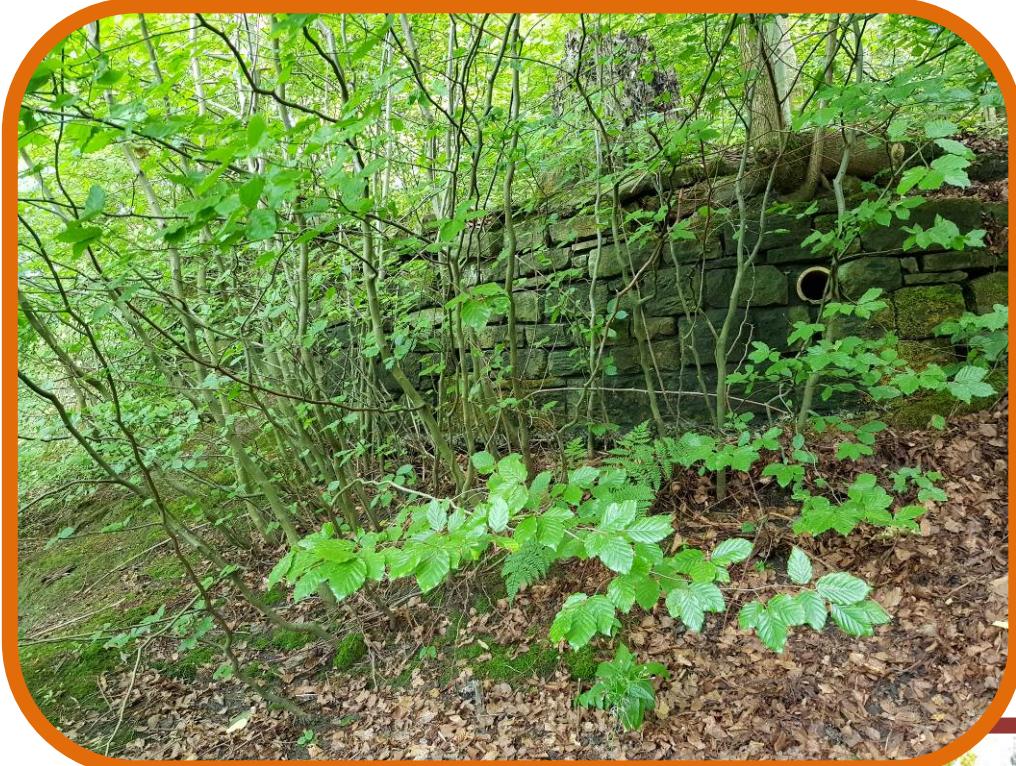
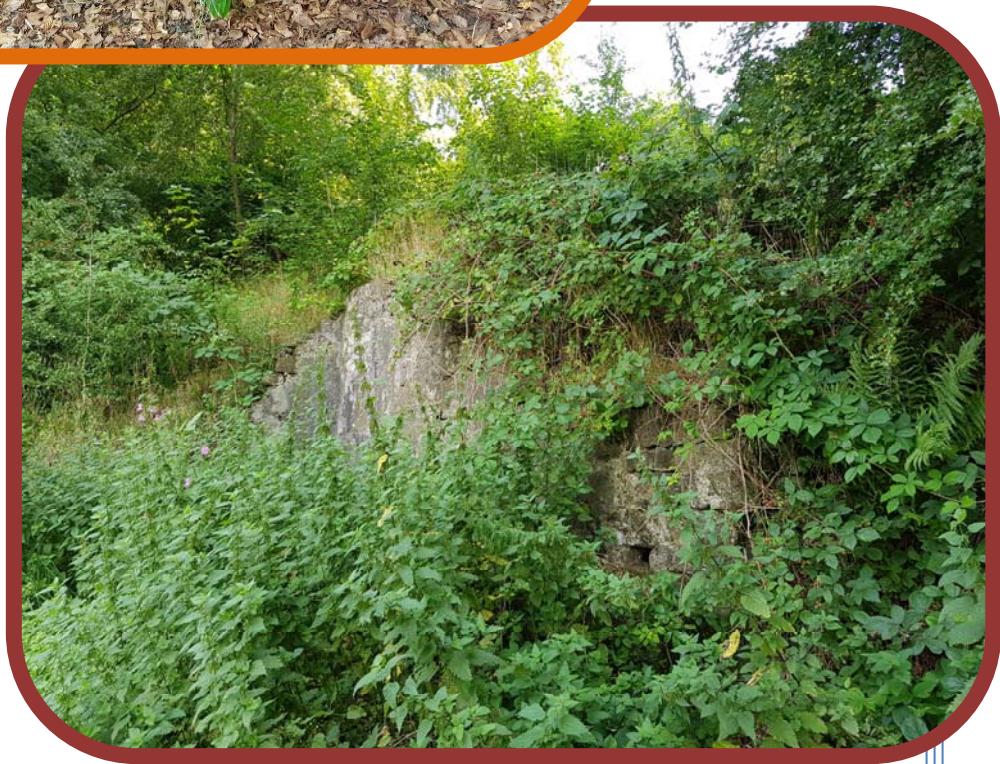
Concern was raised over the condition of the retaining wall, specifically

- A self-seeded ash tree which has caused some movement to the parapet wall
- Cracking in the parapet wall
- Vegetation growing from the wall
- Vertical cracks in the retaining wall visible from the riverside.

The general condition of the retaining wall is average with no apparent major structural issues. The base of the retaining wall was inspected from the river bed to investigate undercutting. None was apparent. The areas of cracking are considered to be consistent with retaining walls of a similar age and are not considered to need remedial action in the short term

- Removal of the ash tree and localised repair to the masonry parapet if required
- General clearance of vegetation from the wall
- Localised repairs to masonry parapet as required.

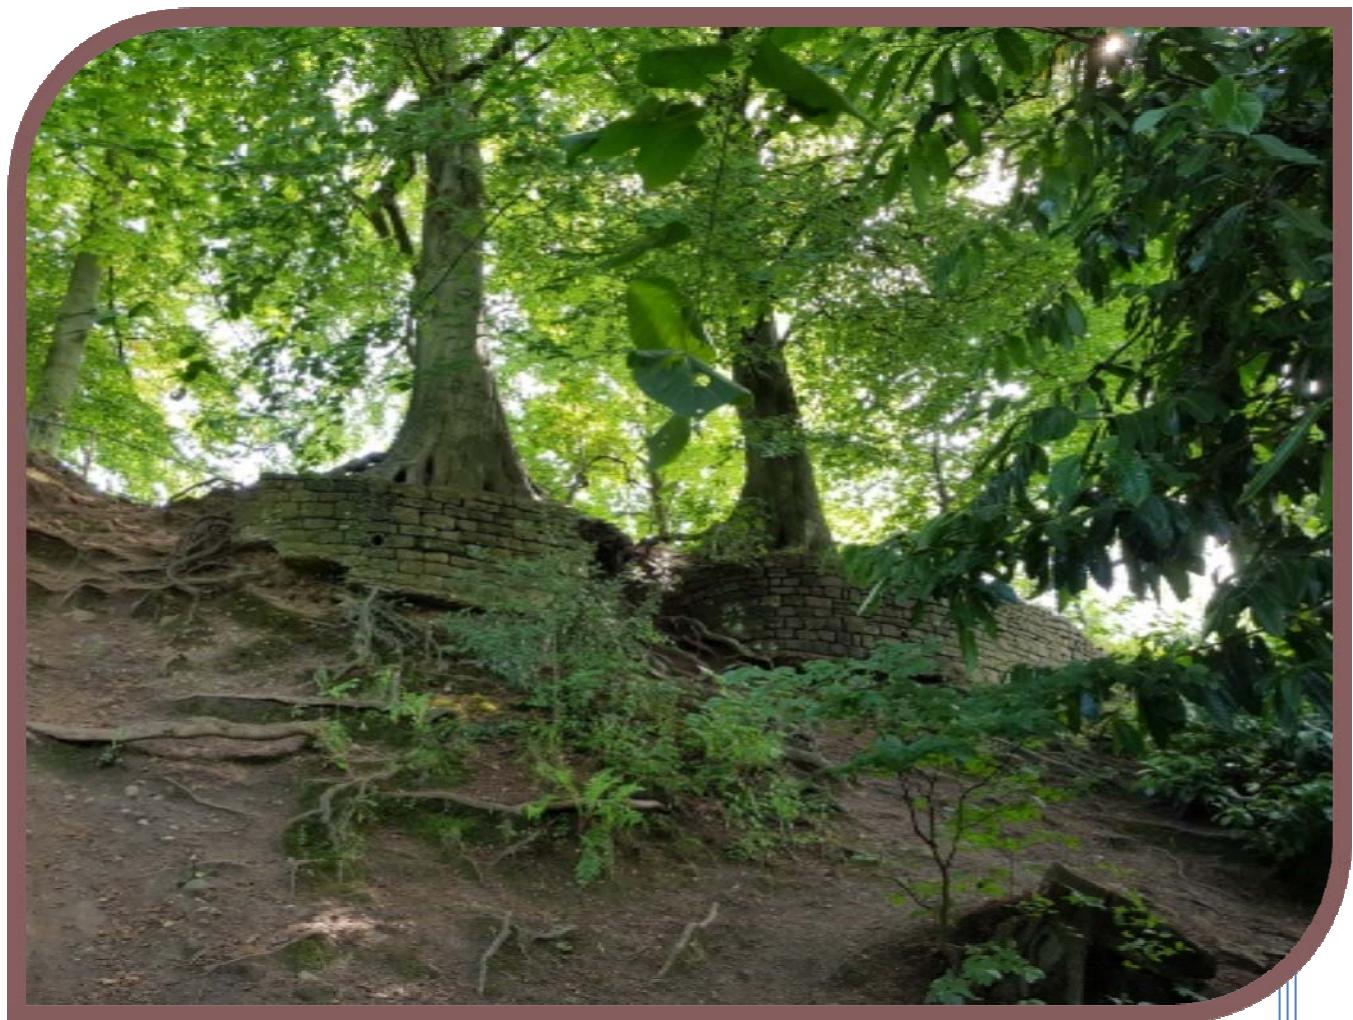
Concern was raised over the condition of the trees and retaining walls on the embankment below Barrowford Cemetery, specifically:

- The stability of the retaining walls around the tree bases
- The stability of the trees themselves.

Parks have regularly had the trees inspected and assessed in terms of their stability. In terms of the curved masonry walls, some of them are in relatively poor condition. Removal is not recommended due to further root exposure and risk of making the trees more vulnerable.

- The trees are inspected and assessed regularly
- Repairs are carried out to the masonry walls as required including new footings to undermined walls and patch repairs as required.
