Agenda Item 7

Benches & Bus Shelters Condition Report 18th September 2015:

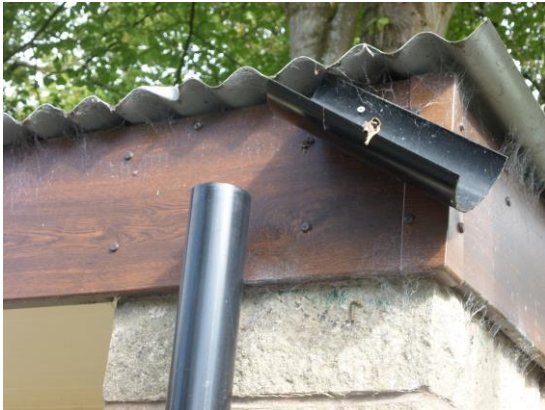
1. **Gisburn Road c/o Barnoldswick Road:** This bus shelter is the one that highlights the most defects the simplest to rectify is replacement of the troughing which has been knocked off by a high vehicle. The Stone built shelter is also showing signs of movement of the back and right hand side wall with visible cracking brought about by the growth of a tree next to the back wall.

Broken Troughing

1. **Dickie Nook:** Needs the tree to the rear felling and the root killing, and the troughing replacing.
2. **Shelter opposite 233 Gisburn Road:** Needs repainting as the paint is peeling particularly to the roadside face.
3. **Gisburn Road c/o Hill Top:** Top l/h end panel window needs replacing.
4. **Gisburn Road, Barrowford opposite Sandy Lane:** Missing front lower panel needs replacing preferably with a metal panel.

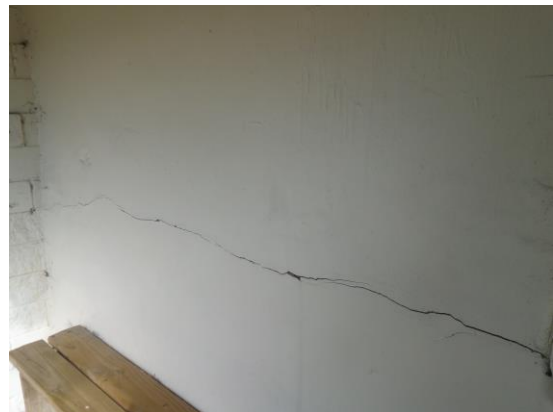
Crack to Rear wall

The movement could be stabilised by the removal of the tree but the Borough Engineer could give a more definitive answer.

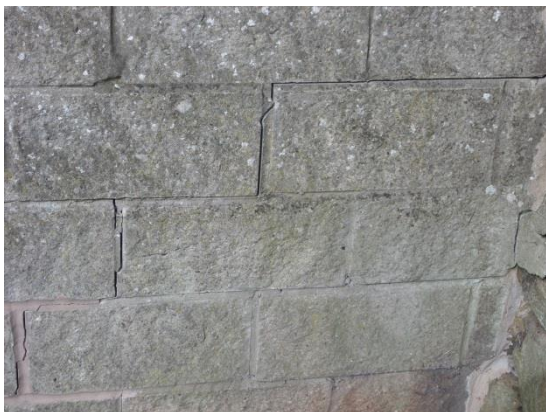
Cracking to R/H Elevation

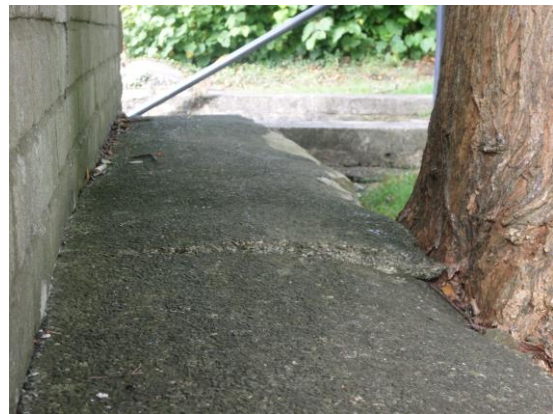
Tree up against Rear Wall

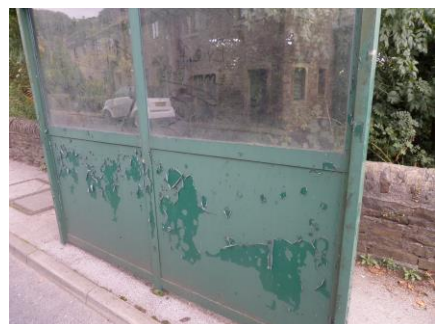
2. **Gisburn Road, Higherford opposite no 233 (Opposite the Fold):** The Shelter needs repainting and cleaning.

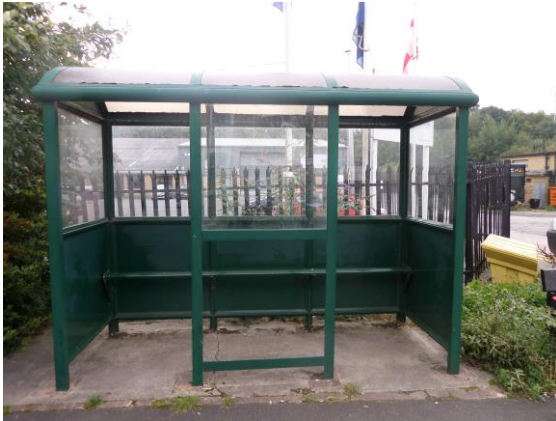
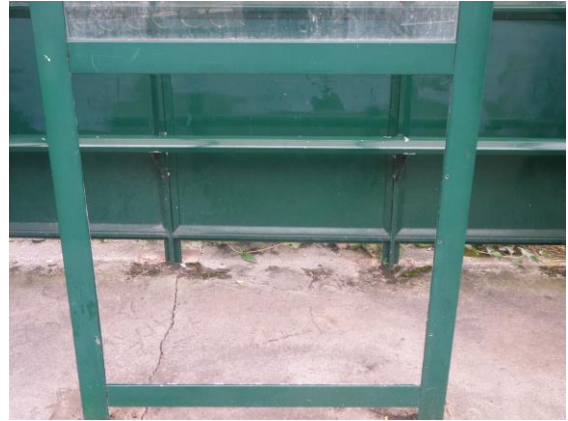
3. **Gisburn Road opposite No 145 (Park Entrance):** Brand New Shelter.
4. **Gisburn Road c/o Portland Street:** Serviceable but needs a good clean.
5. **Gisburn Road, Barrowford opposite Sandy Lane:** Missing front lower panel and needs a good clean.

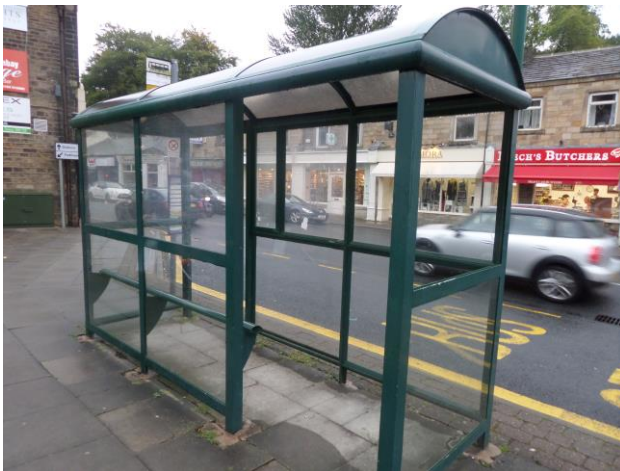
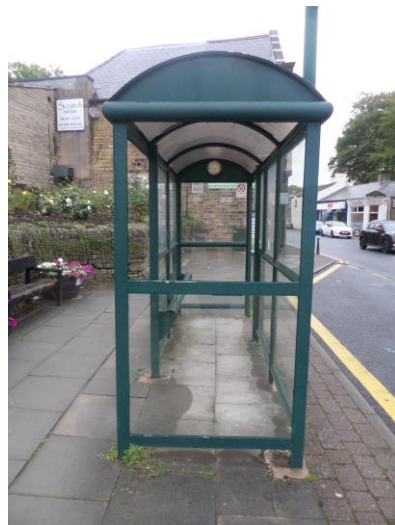
6. **Gisburn Rd, Barrowford, opp 4 Cromwell Terrace:** Structurally sound needs a thorough clean especially roof which is covered with tree sap.
7. **Gisburn Road c/o Hill Top:** Top l/h end panel window missing.
