# Engineering Issues in Barrowford Park

Scott Whalley  
Engineering Manager  
Pendle Borough Council  
September 2019

## Executive Summary

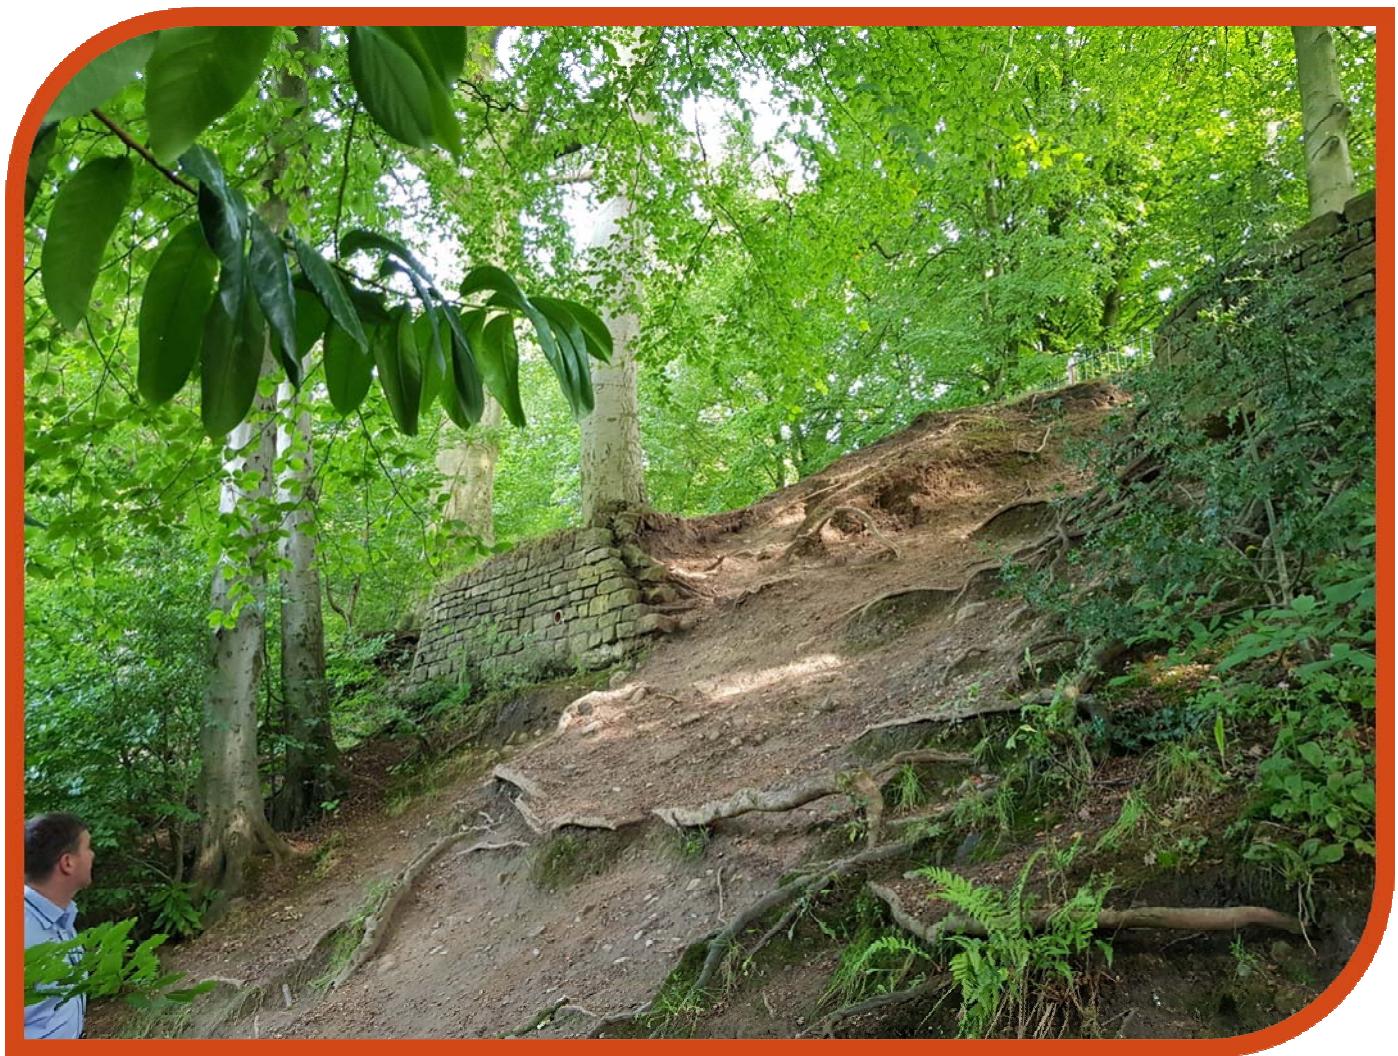
The issues investigated included a masonry retaining wall adjacent to Pendle Water and some curved masonry walls around the bases of large mature trees adjacent to Barrowford Cemetery.

- A self-seeded ash tree which has caused some movement to the parapet wall
- Cracking in the parapet wall
- Vegetation growing from the wall
- Vertical cracks in the retaining wall visible from the riverside.

The general condition of the retaining wall is average with no apparent major structural issues. The base of the retaining wall was inspected from the river bed to investigate undercutting. None was apparent. The areas of cracking are considered to be consistent with retaining walls of a similar age and are not considered to need remedial action in the short term

- Removal of the ash tree and localised repair to the masonry parapet if required
- General clearance of vegetation from the wall
- Localised repairs to masonry parapet as required.
